(Surveyroof Sample)  
Unit 5  
Morris Green Business Park  
Fearnhead Street  
Bolton  
BL3 3PE

# Sample Roof Survey Report

Test Date: 3rd December 2025

Reference: SR-001/SR

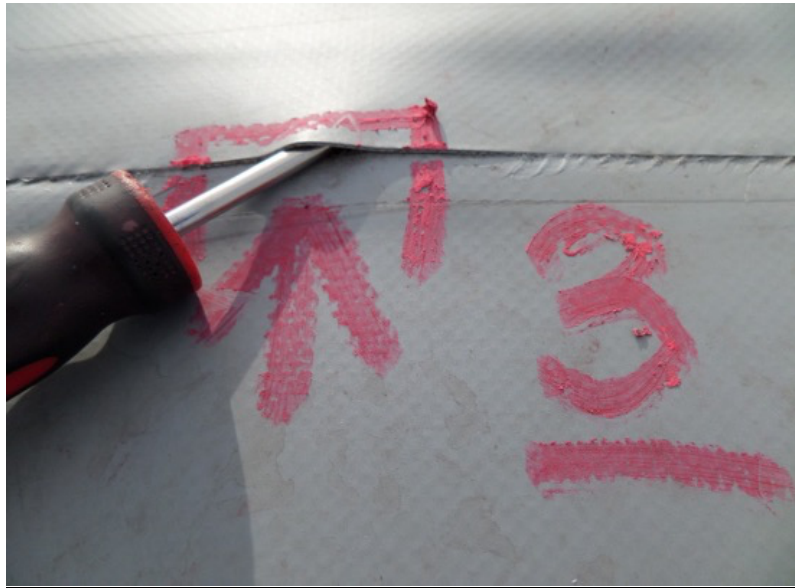
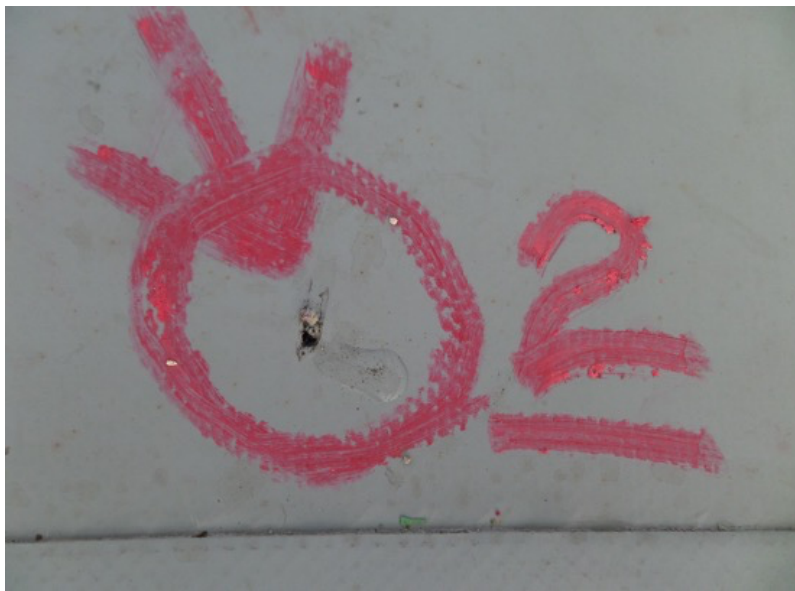
## Breaches or membrane Imperfection Points Identified (**Roof D1**)

| Item | Description |
|---|---|
| 1-2 | Hole/cut/impact damage |
| 3 | Full dilapidated lap/weld |

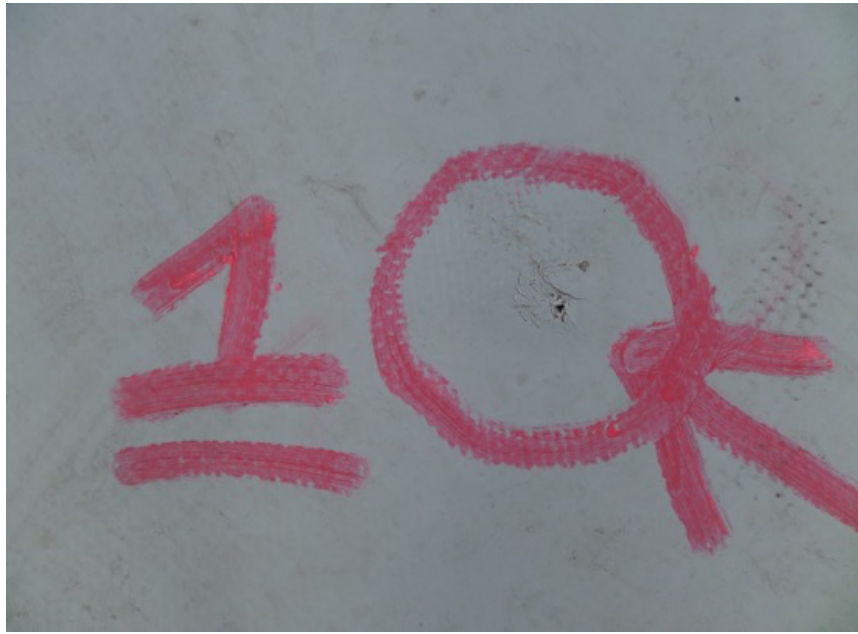
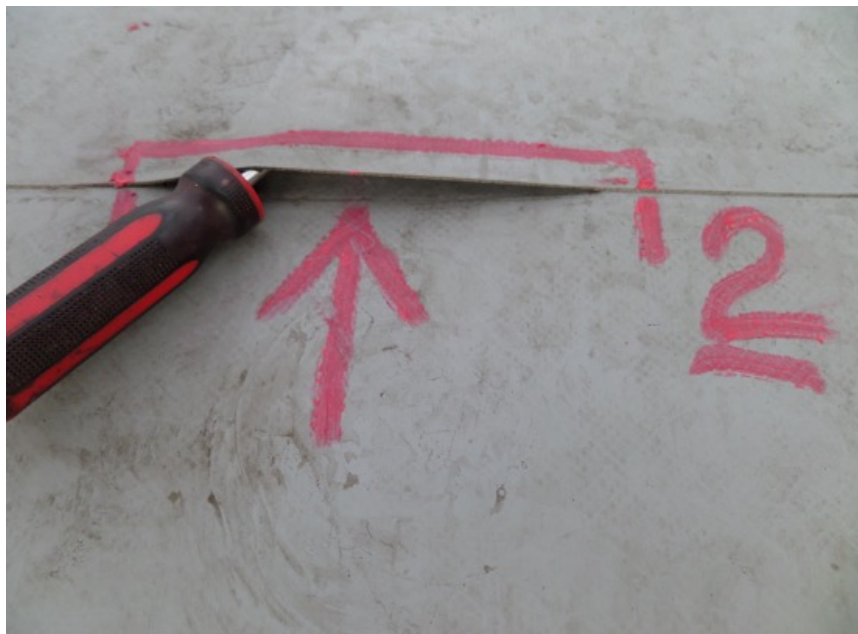
## Breaches or membrane Imperfection Points Identified (**Roof D2**)

| Item | Description |
|---|---|
| 1 | Hole/cut/impact damage |
| 2 | Full dilapidated lap/weld |

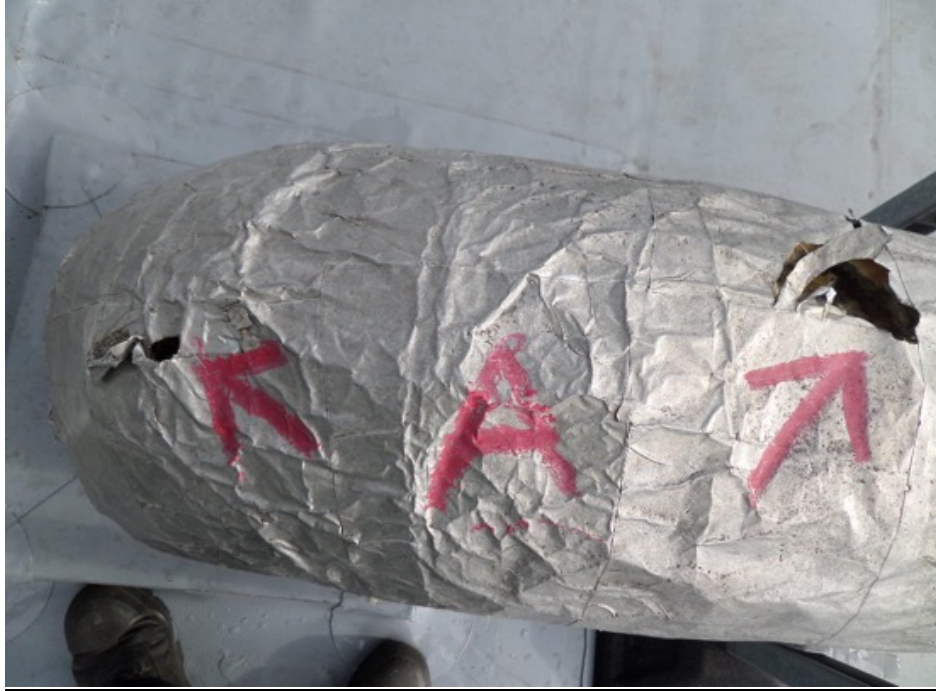
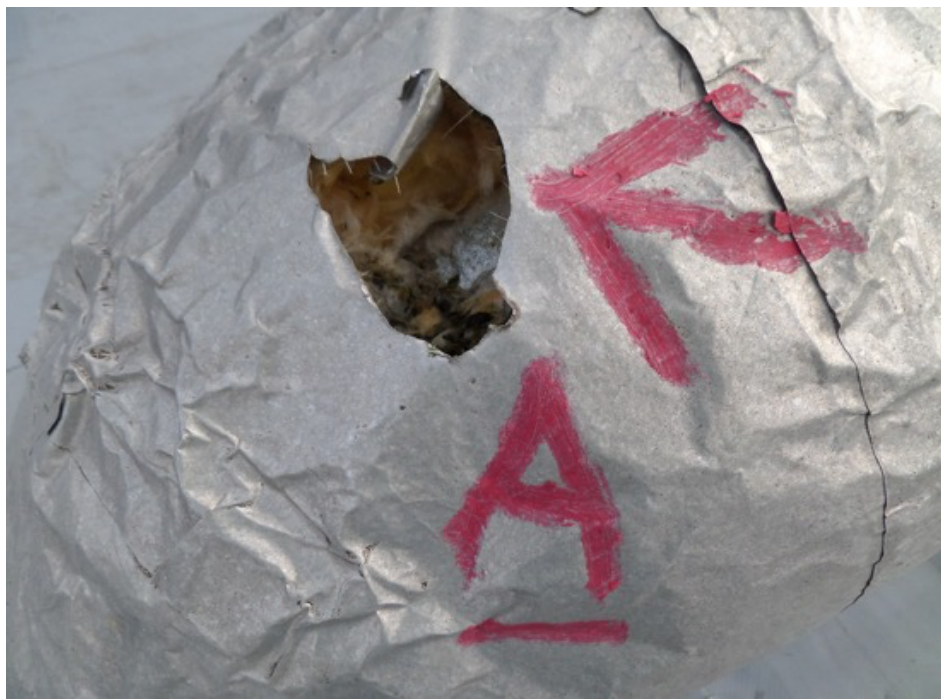
## General Observation to **Roof D2** Area Surveyed

| Item | Description |
|---|---|
| G.O.- A | Damage to the lagging & protective membrane of the ducting directly above where the ducting penetrates the roof X 2 |

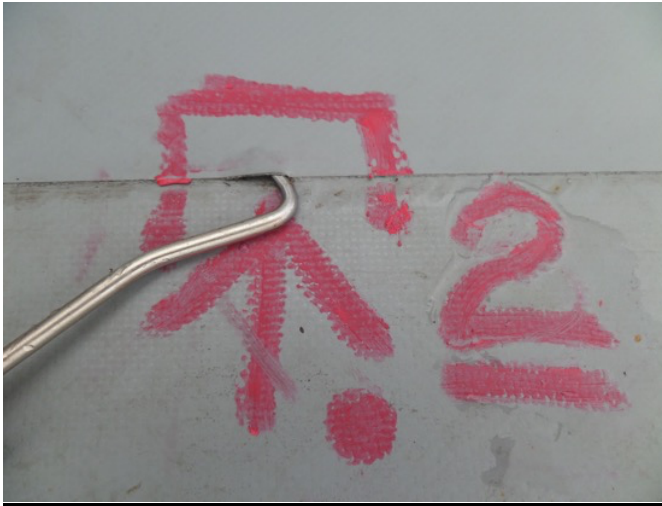
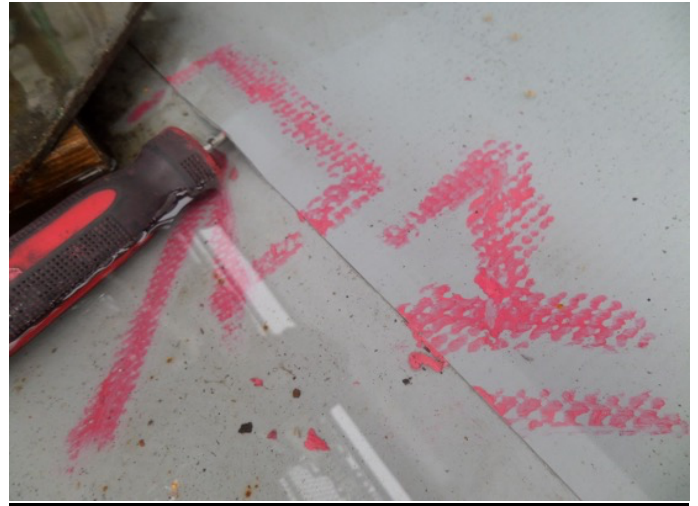
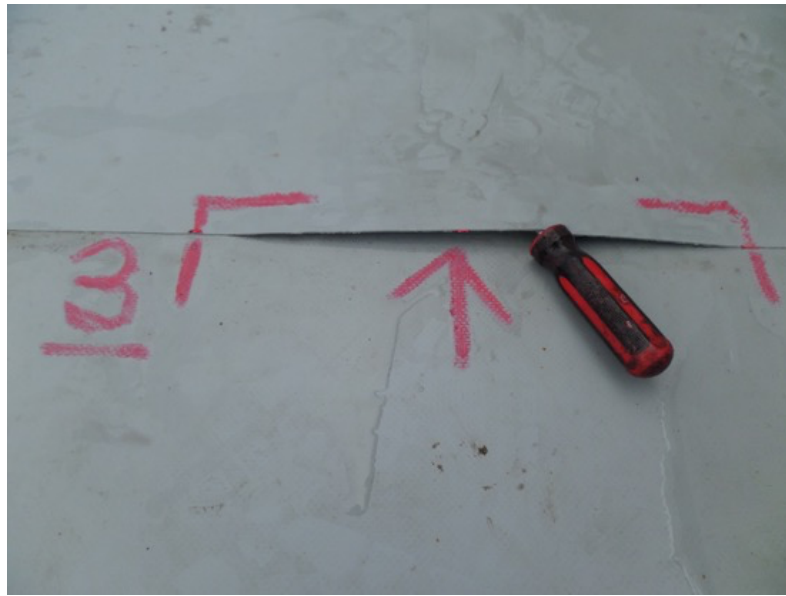
## Breaches or membrane Imperfection Points Identified (**Roof F**)

| Item | Description |
|---|---|
| 1 | Full dilapidated lap/weld |
| 2 | Part dilapidated lap/weld |
| 3 | Full dilapidated lap/weld |

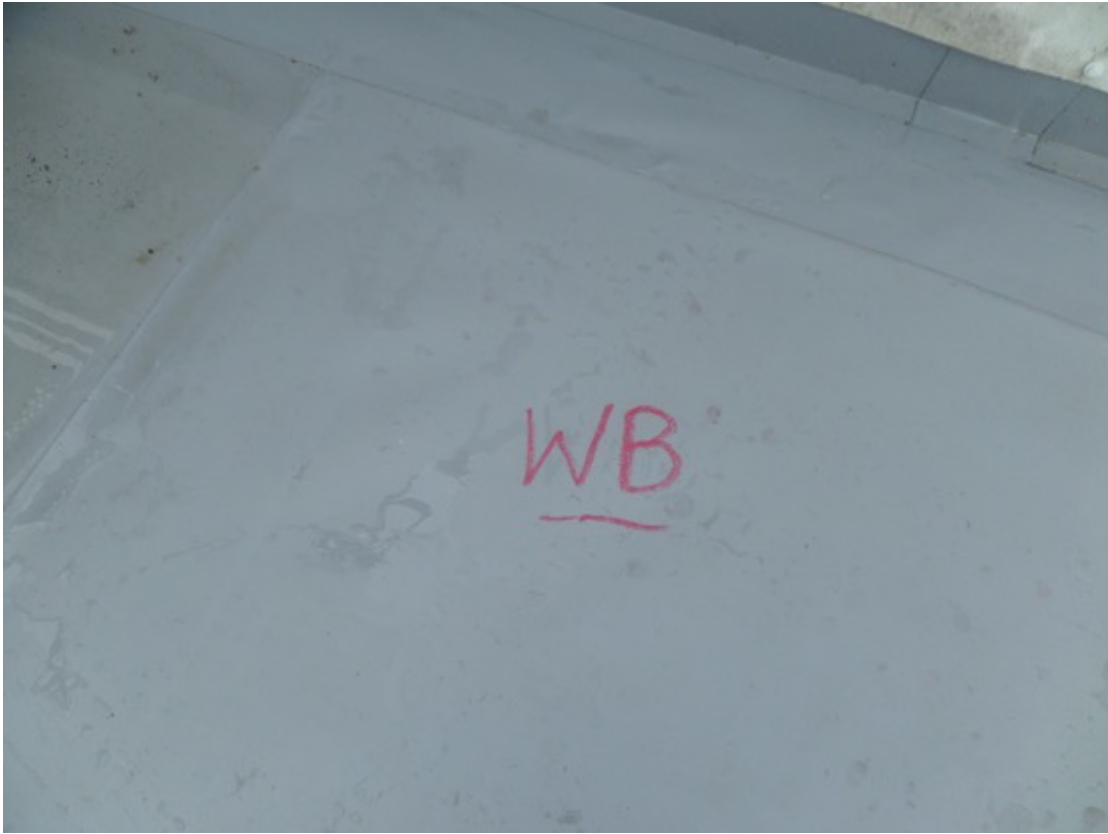
## Other Observations to **Roof F** Area Surveyed

| Item | Description |
|---|---|
| WB | Water blister (water trapped under the membrane, water ingress point is possibly breaches numbered 1, 2 & 3) |
