(Surveyroof Sample)  
Unit 5  
Morris Green Business Park  
Fearnhead Street  
Bolton  
BL3 3PE

# Sample Roof Survey Report

Test Date: 3rd December 2025

Reference: SR-001/SR

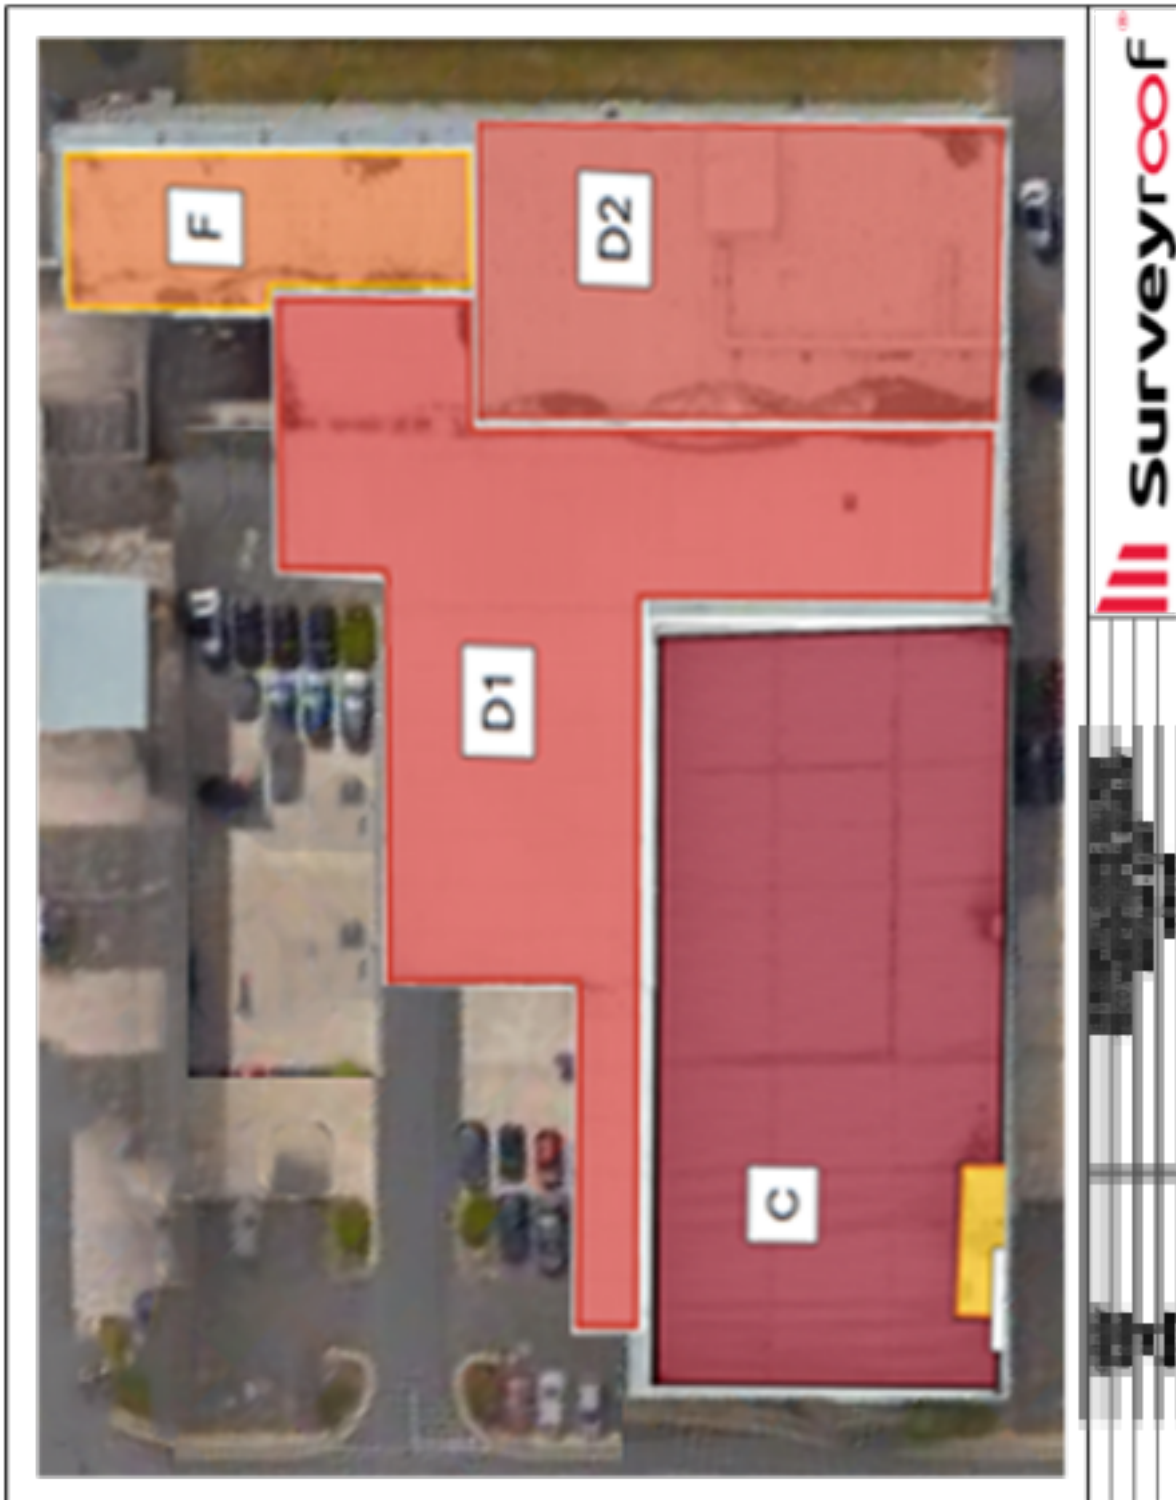
## – Sketch Drawing

The Membrane Condition Survey identified EIGHT breaches or membrane imperfection points plus ONE other observation to the roof areas surveyed that may compromise the integrity of the structural waterproofing. The identified breaches or membrane imperfection points plus the other observation have been marked on the roof areas with survey paint-stick and are included in the photograph section and their location identified on the attached Sketch plan.
